# Ports of Minehead and Watchet

Report of Safety of Navigation within the Watchet  
Port area.

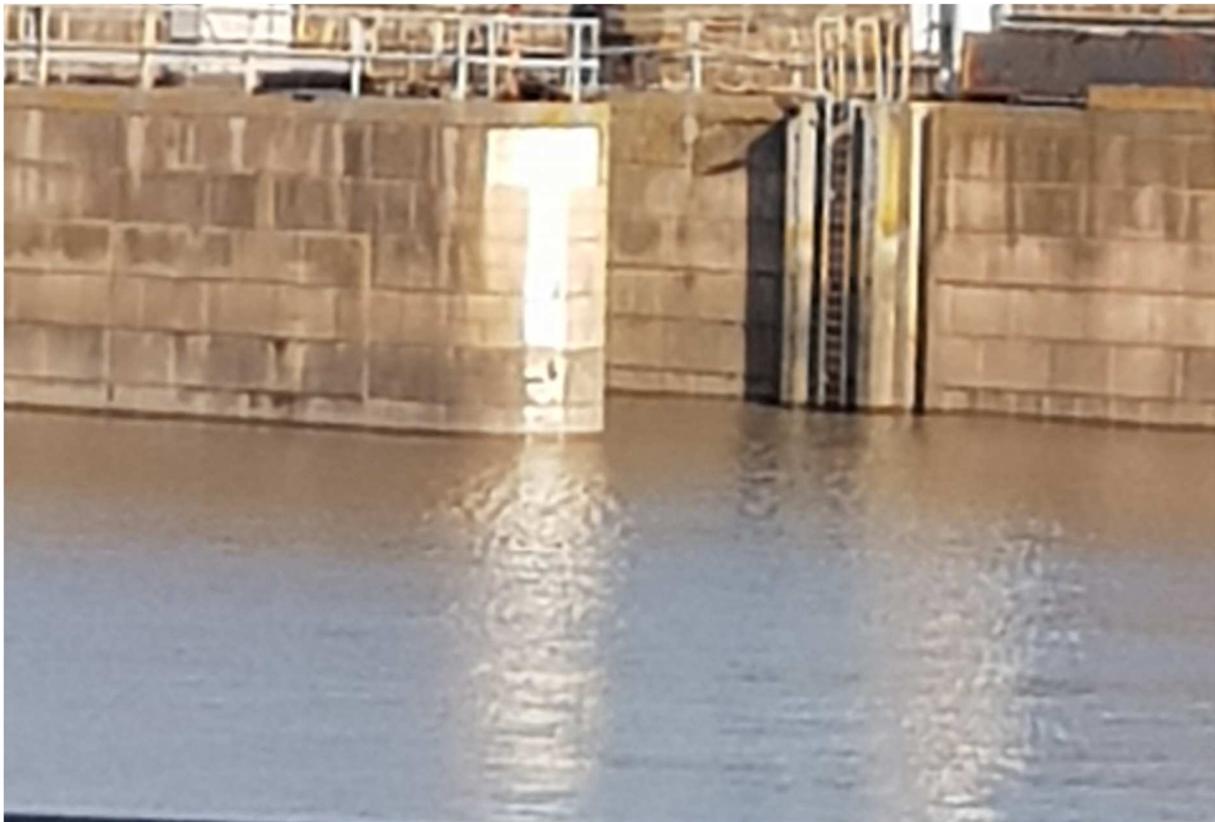
##### 3.1.1 Water depth in the Marina at High Tide.

The visual survey looked at the safe operation of the harbour with regards the mud collection within the outer harbour and marina area. It was seen that at a High Tide of 9.8m at 11:04 that the tide gauge at the marina was showing 5.5m. The tides were close to neaps on the 26<sup>th</sup> February and therefore the tidal level would go higher than this one as recorded. The highest tides in February were on the 21<sup>st</sup> and 22<sup>nd</sup>, which were predicted at 11.9m. A 11.9m tide would register 7.6m within the Marina with slightly less than prediction with an Easterly wind and would be further above prediction with a Westerly wind.

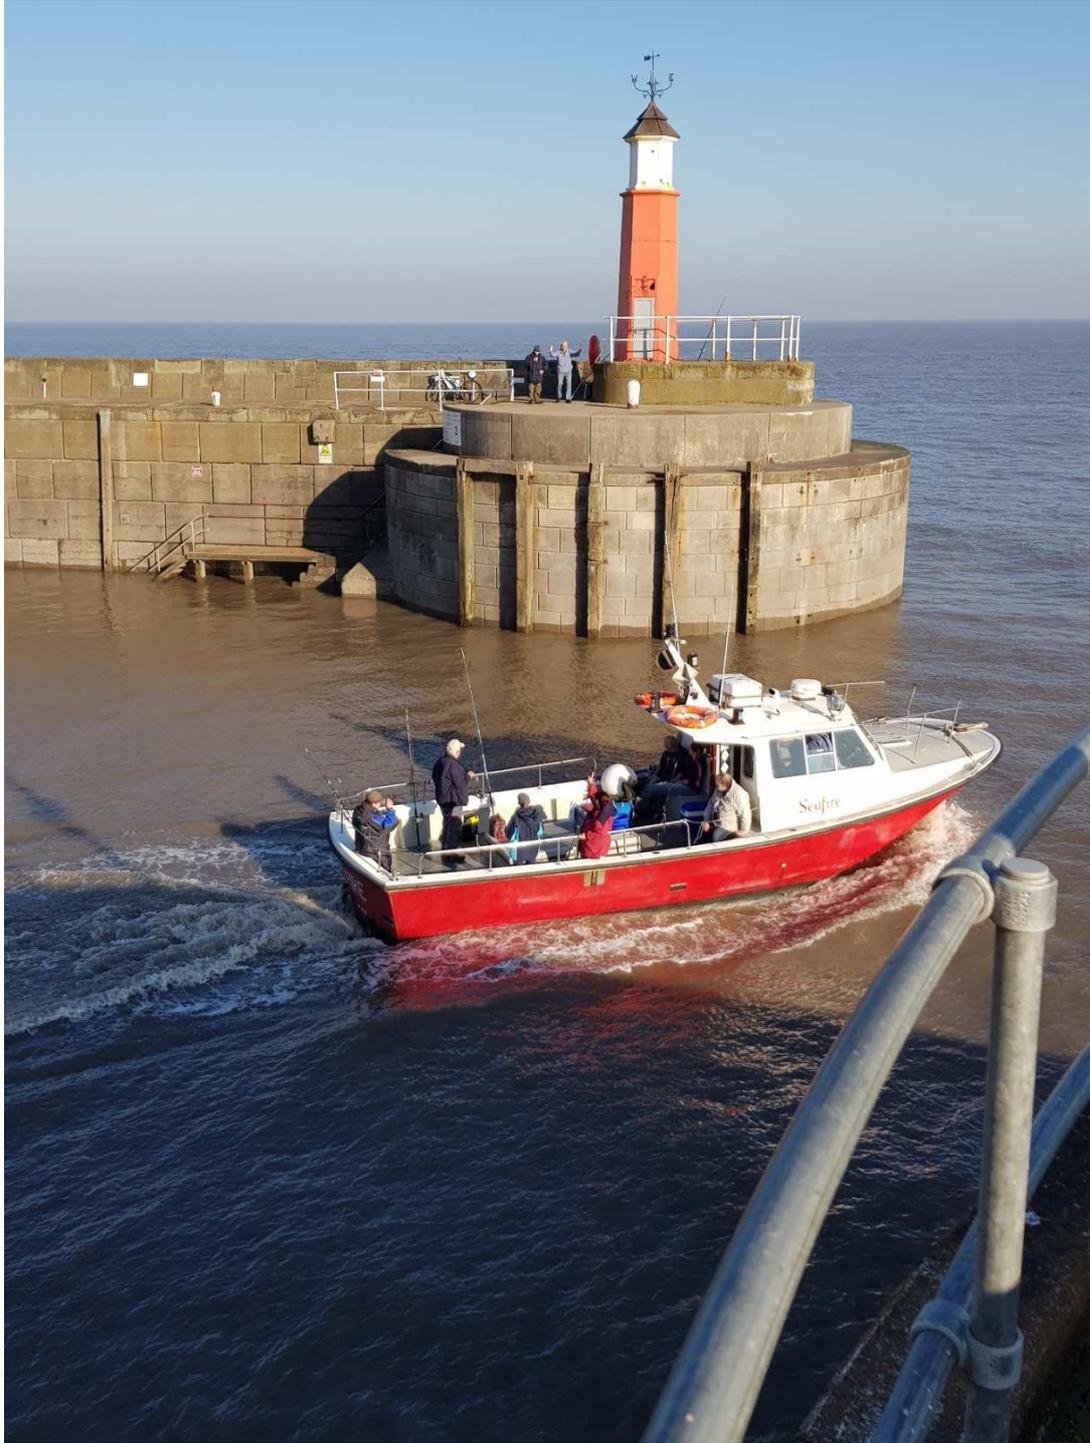
3.2.1 Average sized Watchet Marina vessel leaving the harbour at 09.34 with the tide at 8.3m, showing 4m on the Marina Tide Gauge. Having safely navigated through the marina and outer harbour.

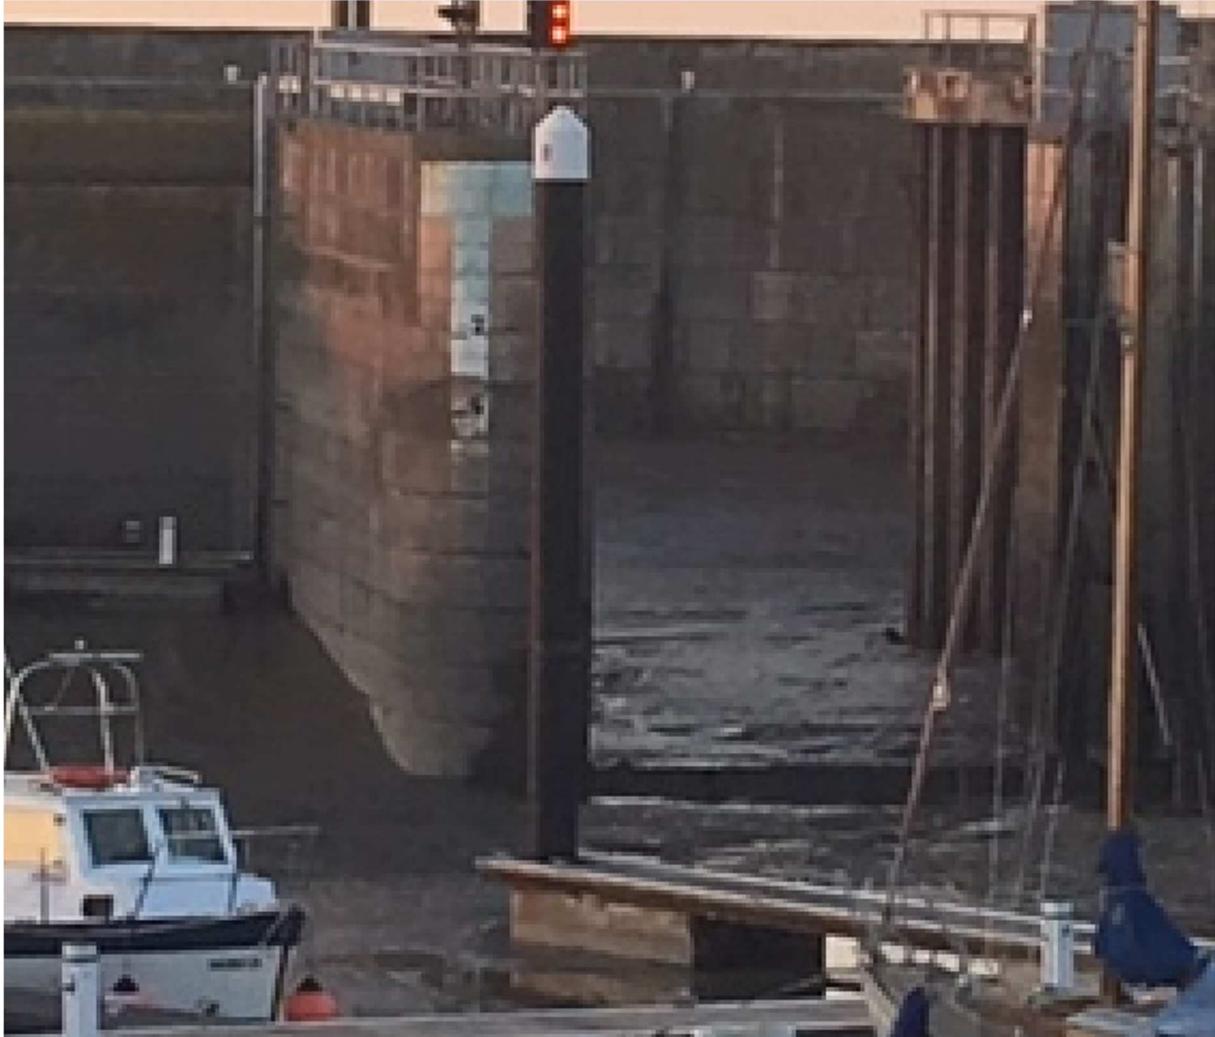
#### 3.3.1 Level of the marina basin at which the mud has collected.

The mud surrounds the tide gauge at 1.75m

Anything above 1.75m on the gauge is therefore water. Taking 1.75m from this reading gives the boat operator the available water. A competent boat operator should therefore be able to assess the water needed for their craft. Bearing in mind that the outer harbour mud is lower than the mud in the marina a vessel correctly gauging the water level will be able to leave the marina safely and therefore navigate safely through the outer harbour.

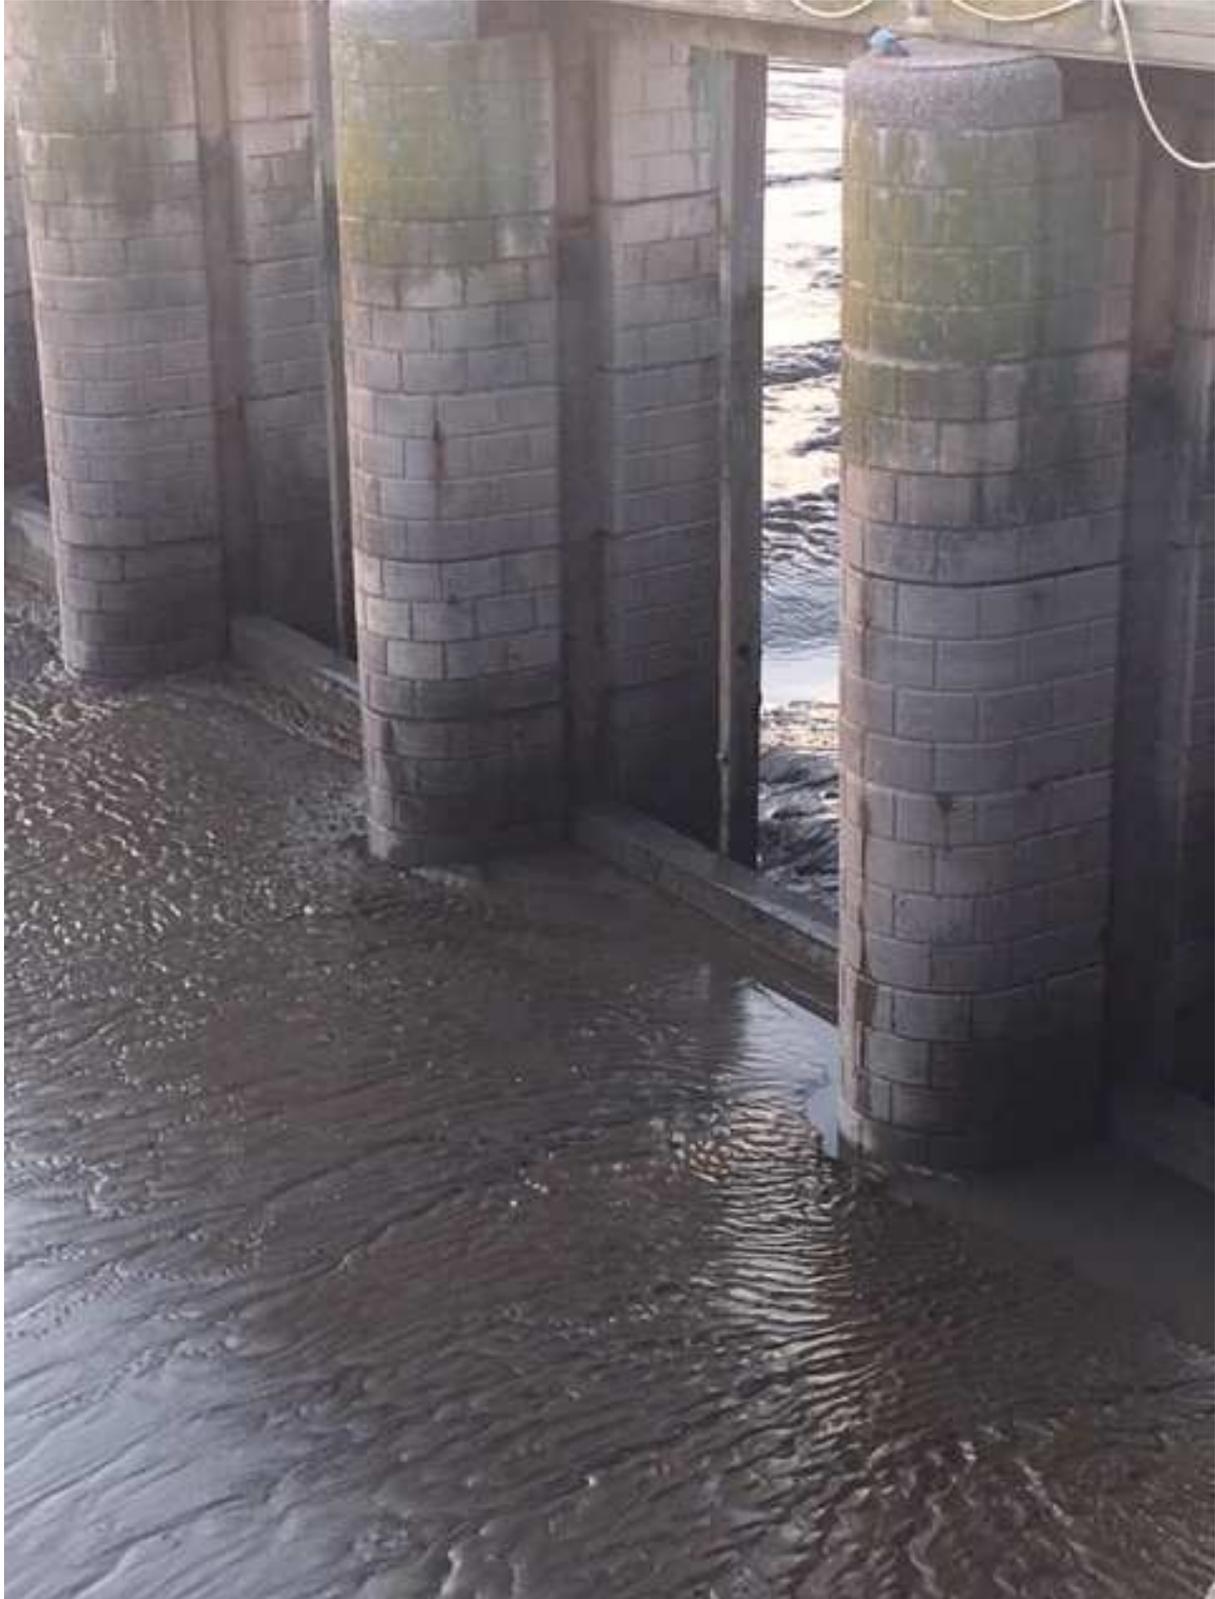
3.3.2 Mud in the Outer Harbour is lower than the Marina.

Further the mud is currently higher in the marina than the outer harbour as seen in 3.3.2, therefore any vessel navigating the marina should safely navigate the through the outer harbour.
